**Name Of Dam:** STONY CREEK NO. 9

**Location:** SHENANDOAH COUNTY, STATE OF VIRGINIA

**Inventory Number:** VA 17101

## PHASE I INSPECTION REPORT

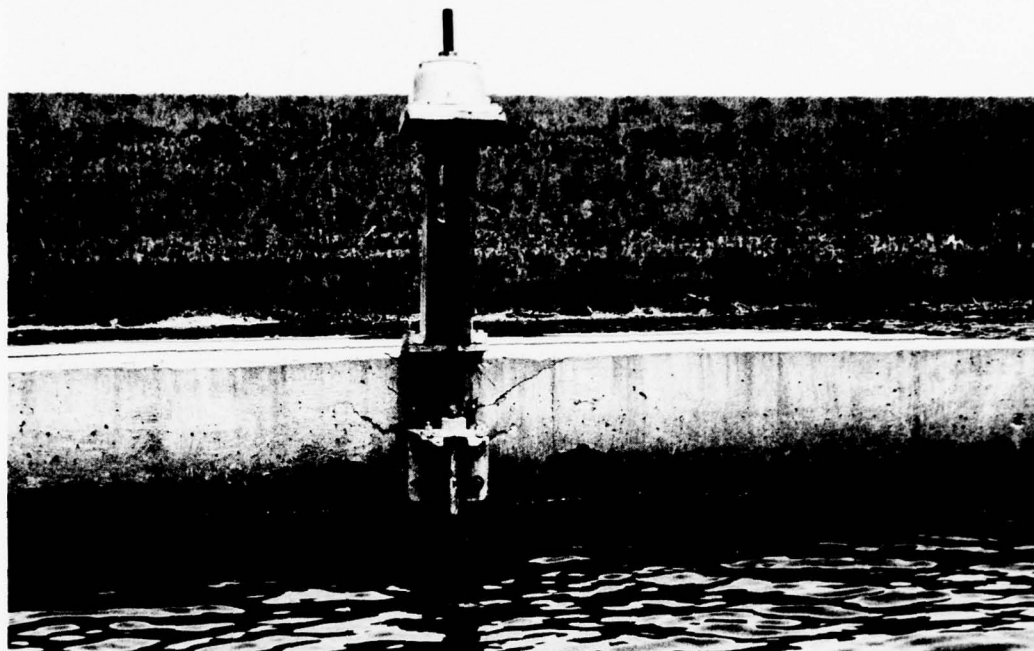
PHOTO 1

3.1.3 Appurtenant Structures: At the time of the inspection, the trash racks were being held in place by cables since the bolts were sheared off by ice loads. In addition, the lift pedestal which controls the emergency gate is cracked at its mounting and is not operational (see Photos 1 and 2). It is recommended that the trash racks be refastened to the concrete structure, and that the lift pedestal mounting be repaired and reattached to the concrete. For safety reasons, a locking device should be put on the manhole cover on the intake structure.

- 6.2.1 Visual Observations: No evidence of instability in the embankment or cut slopes was observed. There are some structural cracks in the riser (see Photos 1 and 2). Clear seepage was noticed in the vicinity of the outlet of the principal spillway on both sides (see Photos 3 and 5). Minor, clear seepage occurs in the bench on the downstream slope at the left abutment.

- 1) The repair of erosion development, possibly by stone gutters, on the right downstream abutment.
- 2) Reseeding a major portion of the downstream and upstream face where indicated.
- 3) Repair of the lift pedestal and trash racks on the principal spillway.
- 4) Installation of a locking manhole cover as specified on the plans.
- 5) Stability analyses using as-built conditions.
- 6) Further investigation of the clear seepage at the downstream toe.
- 7) Development of a warning system that will alert downstream residents when the reservoir level approaches the emergency spillway.

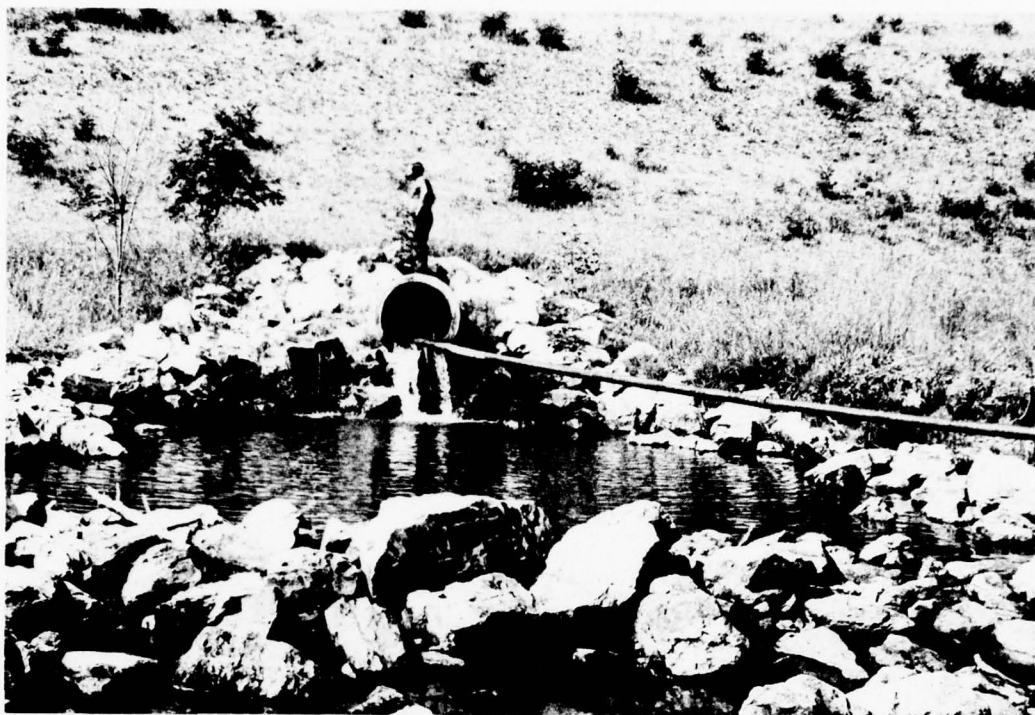
PHOTO 3

STAFF GAGE AND RECORDER	None	
DRAINS	There are two 6 inch BCCMP drains exiting at the stilling basin. These drains were flowing partially full at the time of our inspection (Photo 3). The drains, according to the plans, receive flow from the drainage trench under the dam toe.	These drains should be inspected regularly to insure they are flowing and are not plugged.
FOUNDATION	The foundation is on gray, soft-jointed shale with sandstone interbedded (Chemung formation) according to the borings and test pits on the as-built drawings. The dip varies from 20° to 27° SE. The attitude of the bedding as measured in the emergency spillway and rock exposures in the vicinity strikes N. 30° E.

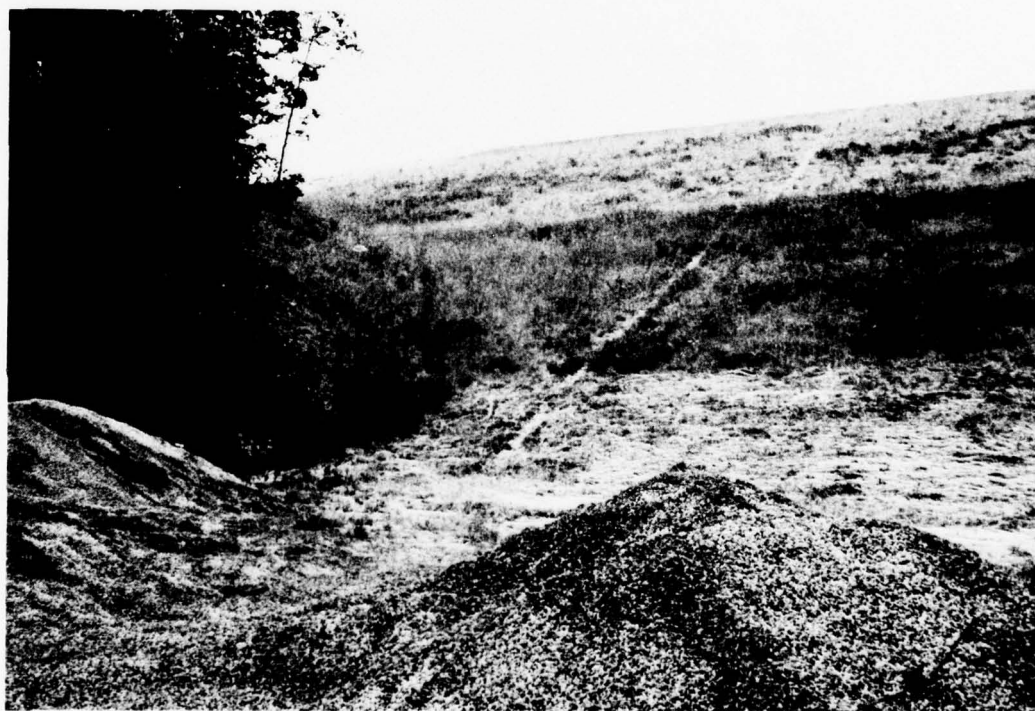
**PHOTO 6**

3.1.2 Dam: Erosion problems are present at three places on the downstream face of the embankment. One is a pedestrian path straight up the face of the embankment (see Photo 6). The other two places are the abutment contact areas. The pedestrian path should be filled and reseeded. Rubble gutters should be installed on the contact areas to prevent further erosion. Also, the upstream shore of the embankment is being wave eroded and should be riprapped if the condition worsens and creates a slope stability problem.

- 6.2.3 Operating Records: The yearly inspections indicate no deteriorating conditions beyond minor surface erosion (see Photo 6) which has been controlled by seeding. High water marks on the upstream slope above the normal pool indicate that the water elevation has risen without any significant damage to the dam.
